## ADCP OS150 Issue

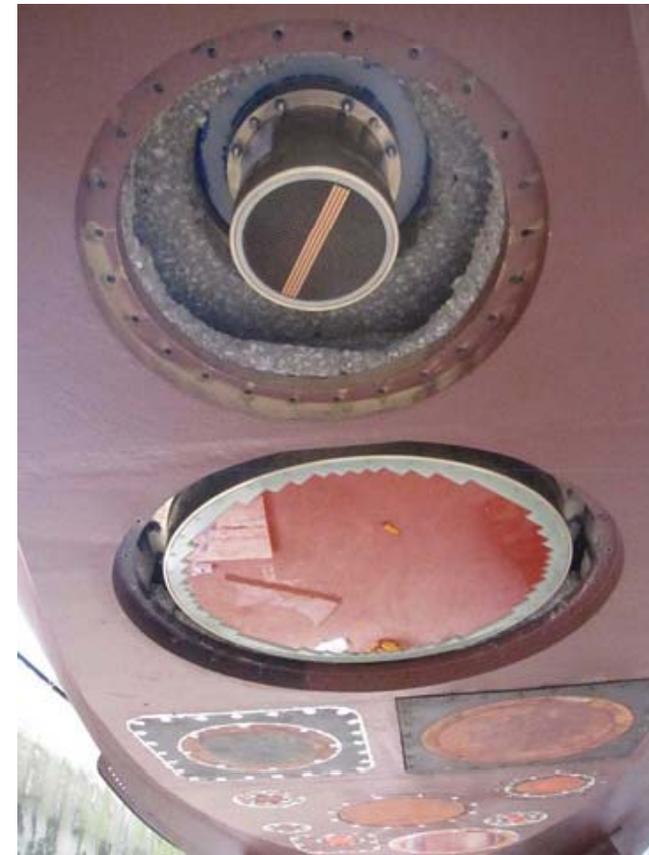
- Discovery of problems on ADCP OS150 on board Atalante April 2011, confirm in July 2011.
- New installation of ADCP on board Thalassa in July 2011. ADCP OS150 doesn't follow furnisher specifications at sea trials on august 2011.

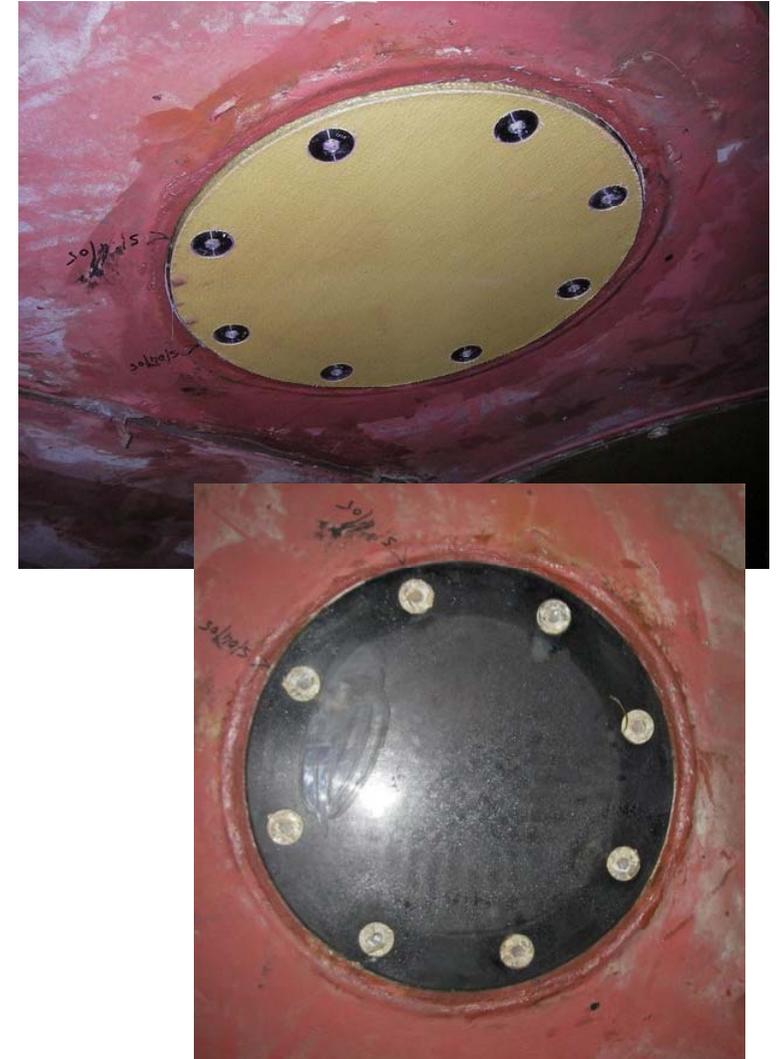
After sea trials on board Atalante in July 2011 and Thalassa in August 2011 (after installation of new ADCPs), we noted that :

- ⇒ difference between speed GPS and bottom track
- ⇒ sound range too short
- ⇒ first speed current layers proportional to vessel speed

### ➤ Idea : issue of ADCP OS150 acoustic windows

**Is it only an acoustic windows issue or is it more complex ?**

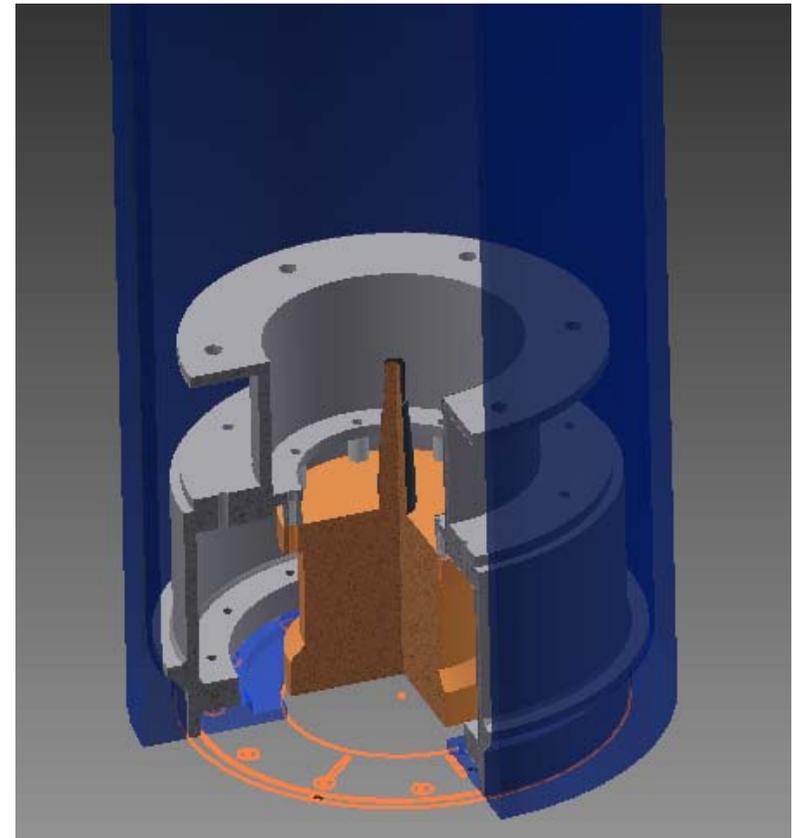
Tests in acoustic tank of several acoustic windows.

We tested different materials and several thickness.

First trials of ADCP OS150 with 2 new acoustic windows on TVO, on board Thalassa.

⇒ results are better than in August. Need to continue in this way.
