# Lessons Learnt from the DOMS Mooring Parting Accident

## 5<sup>th</sup> UK Moorings Workshop

# PAP1 mooring parted

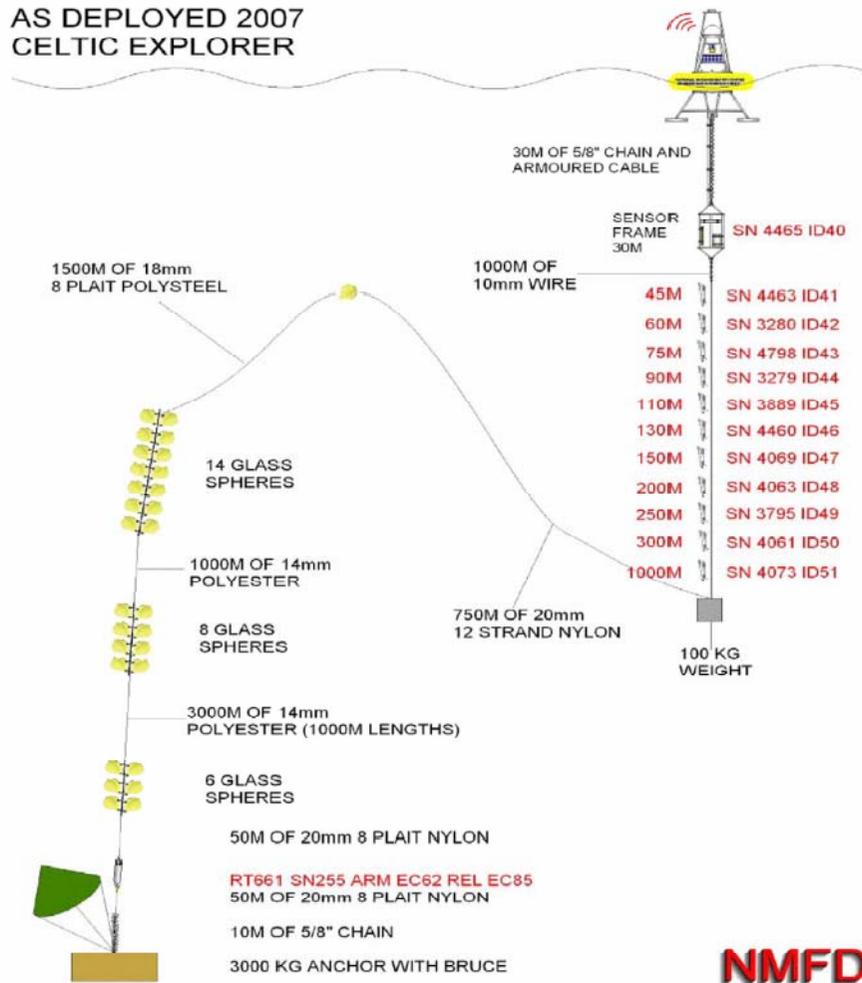
PAP1 DOMS  
AS DEPLOYED 2007  
CELTIC EXPLORER

A new multidisciplinary mooring DOMS (Deep Ocean Monitoring Station) was deployed at the PAP time series observatory in June 2007.

The mooring had a design specification duration of 18 months.

Various features failed and the mooring ultimately parted 47 days after deployment.

The top part of the mooring was recovered by R/V Pelagia in September 2007.

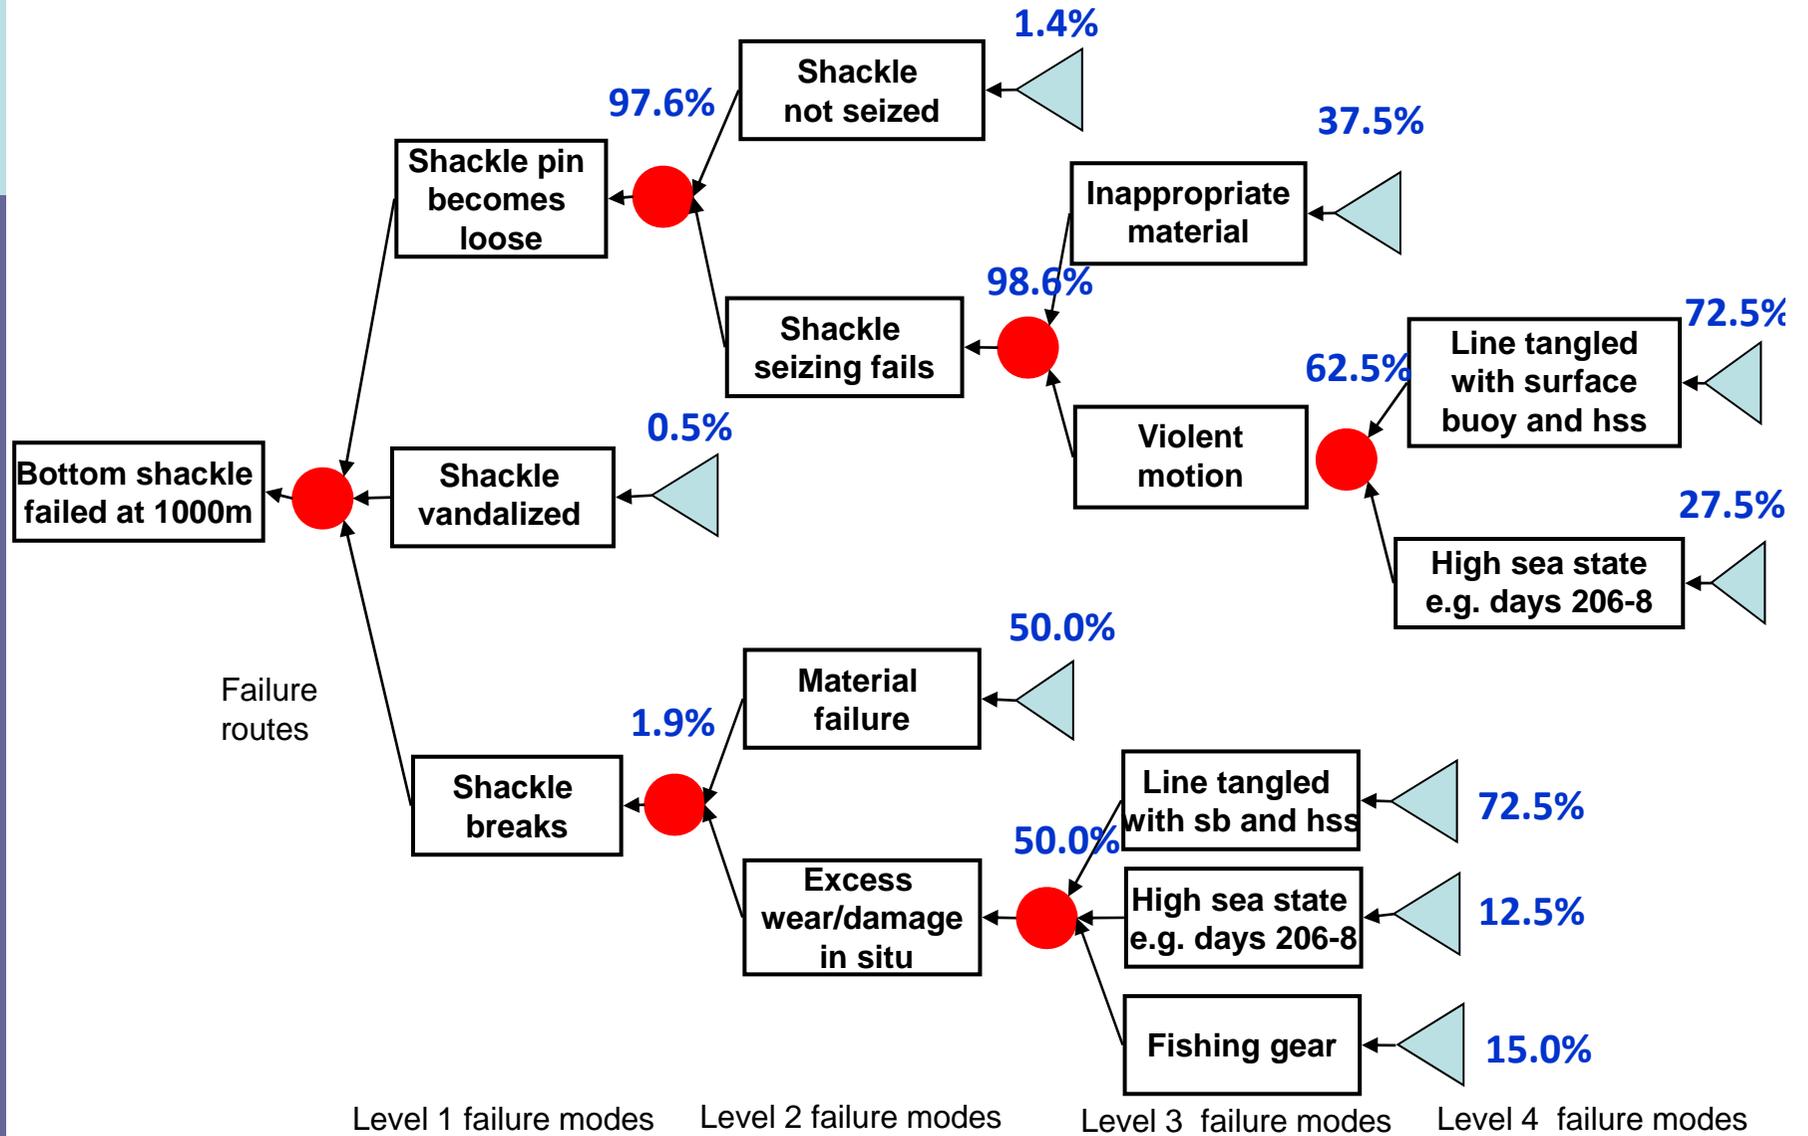
Level	N	Failure Mode	Likelihoods
5	4	Line tangled with sb and high sea state	43.6%
4	3	Inappropriate material for the shackle seizing	36.1%
6	5	High sea state e.g. days 206-8	16.5%
3	2	Shackle not seized	1.37%
3	6	Material failure	0.94%
4	7	Line tangled with sb and high sea state	0.68%
2	1	Shackle vandalised	0.55%
4	8	High sea state e.g. days 206-8	0.12%
4	9	Fishing gear	0.14%
<b>Total</b>			<b>100%</b>

*Failure modes identified using the fault tree analysis. Three experts assessed all evidence collected from the investigation.*

Design fault was considered to be the root cause for the parting of the mooring.

Bad seizing of the shackle may also have contributed to the accident

- 1: Change design so there is no floating horizontal line to tangle with the surface float.
- 2: Incorporate restraints on shackles to reduce damage at junctions.
- 3: Put an AIS proximity sensor on the surface buoy which will automatically transmit the identity of a nearby vessel.
- 4: Surround mooring with guard buoys.
- 5: Install proximity activated camera on surface buoy with satellite transmission.
- 6: Acoustic warning of approaching ship.
- 7: Develop communication with tuna fishermen (possibly through ICCAT) both to encourage them to avoid the area and to design more durable moorings.
- 8: Advise location on all charts and in fishermen's magazines.

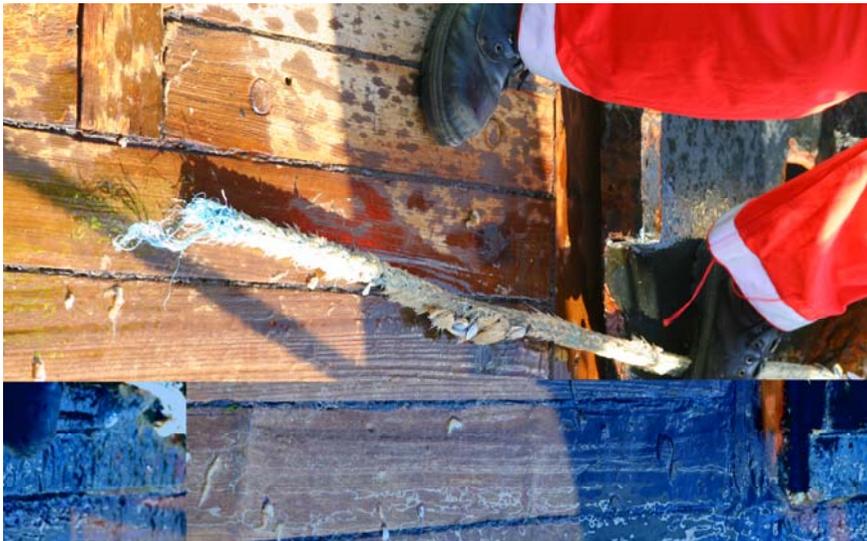
- On 2<sup>nd</sup> October 2008 all of the expected mooring was recovered except for a single top 17" sphere, 750m of nylon rope and a 100kg weight.
- The upper 1500m rope section of the mooring had been cut.
- Long line fishing gear (hooks and line) entangled were found entangled with the rope.
- The rope had been stopped off several times and there was antifouling paint along lengths of the rope.

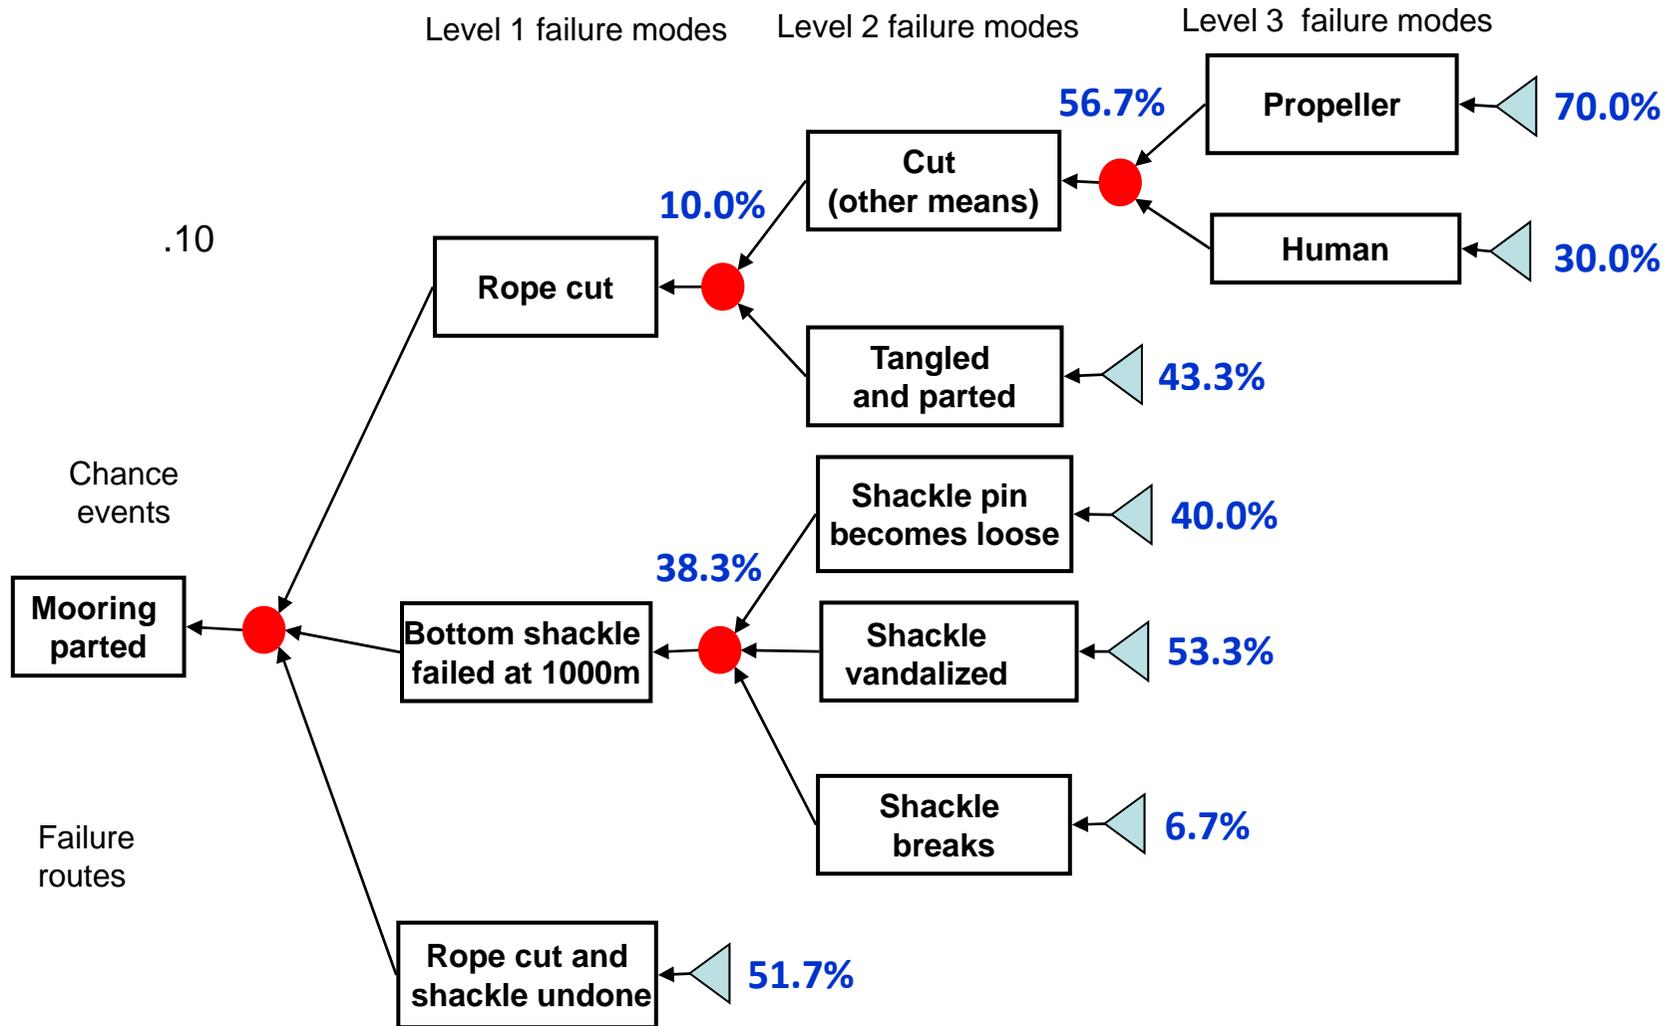
Level	N	Failure Mode	Likelihoods
1	1	Rope cut and shackle undone	51.7%
3	2	Bottom shackle failed- shackle vandalized	20.4%
4	3	Bottom shackle failed - shackle pin becomes loose - inappropriate material	5.67%
5	4	Bottom shackle failed - shackle pin becomes loose – line tangled with sb and hss	6.84%
2	5	Rope cut – tangled and parted	4.33%
3	6	Rope cut – human	3.97%
5	7	Bottom shackle failed - shackle pin becomes loose – high sea state e.g. days 206-8	2.59%
3	8	Rope cut – propeller	1.7%
3	9	Bottom shackle failed - shackle breaks – material failure	1.28%
4	10	Bottom shackle failed - shackle breaks – line tangled with sb and hss	0.93%
3	11	Bottom shackle failed- shackle pin becomes loose - shackle not seized	0.21%
4	12	Bottom shackle failed - shackle breaks – fishing gear	0.19%
4	13	Bottom shackle failed - shackle breaks – high sea state e.g. days 206-8	0.16%
<b>Total</b>			<b>100%</b>

***Failure modes. Fishing activity is deemed the top reason for the parting of the top side of the mooring.***
